# Manhole Inspection Summary

Manhole # S23M\_\_020MH

Insp Date: **6/18/08 9:52 AM**

**Location** Address: **507 S Vincent St**

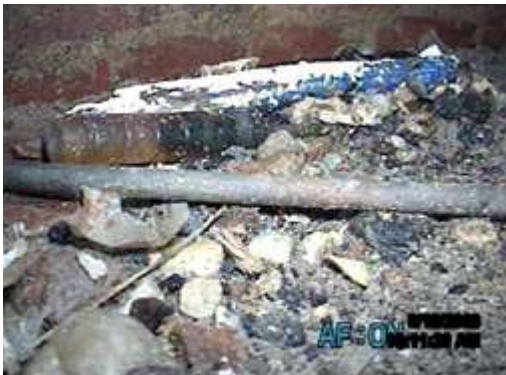
Miscellaneous

channel debris

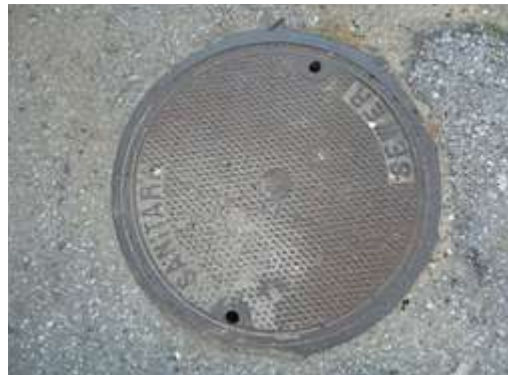
Miscellaneous

MH Cover

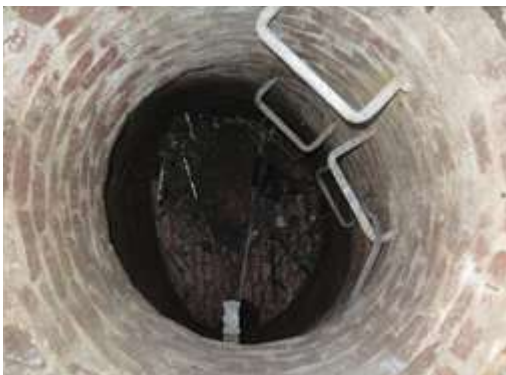
Defect 5

☒ **Evidence Of Surcharge** Depth: **3** (ft.) ☐ Active Surcharge Present

surcharge evidence

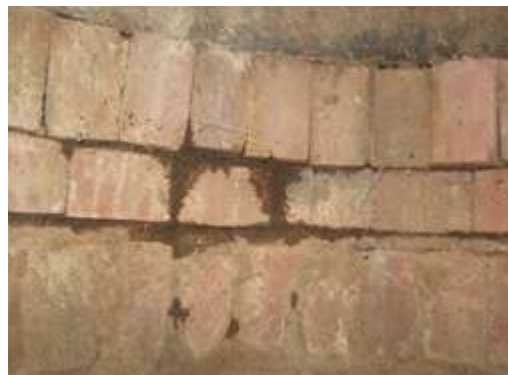
Defect 3

Infiltration: ☐ None ☐ Joint ☐ Cracks ☒ **Mortar** ☐ Roots ☐ Wall

infiltration at chimney mortar

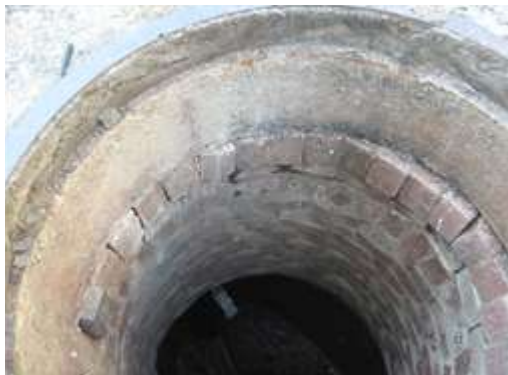
Defect 4

Offset: **1** (in.)

Frame Offset

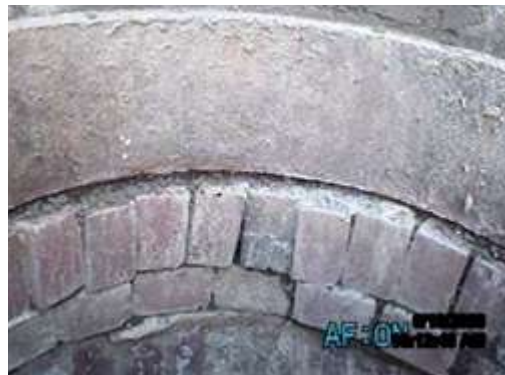
Defect 2

Condition: ☐ Sound ☐ Cracked ☐ Root Intrusion ☒ **Loose Brick** ☐ Deteriorated

chimney had several loose brick

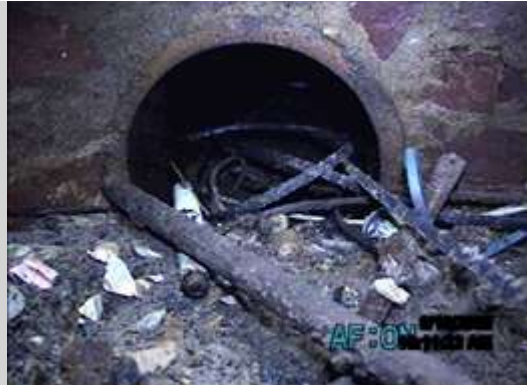
12 O'Clock Outflow

8 in. Circular Gravity Sewer  
Pipe Out @ 12 O'Clock

Deposits: ☐ None ☐ Mud ☐ Sludge ☒ **Debris** ☐ Grease

Silt Depth: **0** (in.) Deposits Extent: **Medium**
